North Coast Regional Water Quality Control Board

Inspection Report for October 23, 2019 Inspection of Mendocino County Assessor's Parcel Number 037-620-07-00

File: Cannabis Program Inspections, Mendocino County, October 23, 2019
CAE Holdings Inc. and Ehud Lissauer, CIWQS Place ID 844208

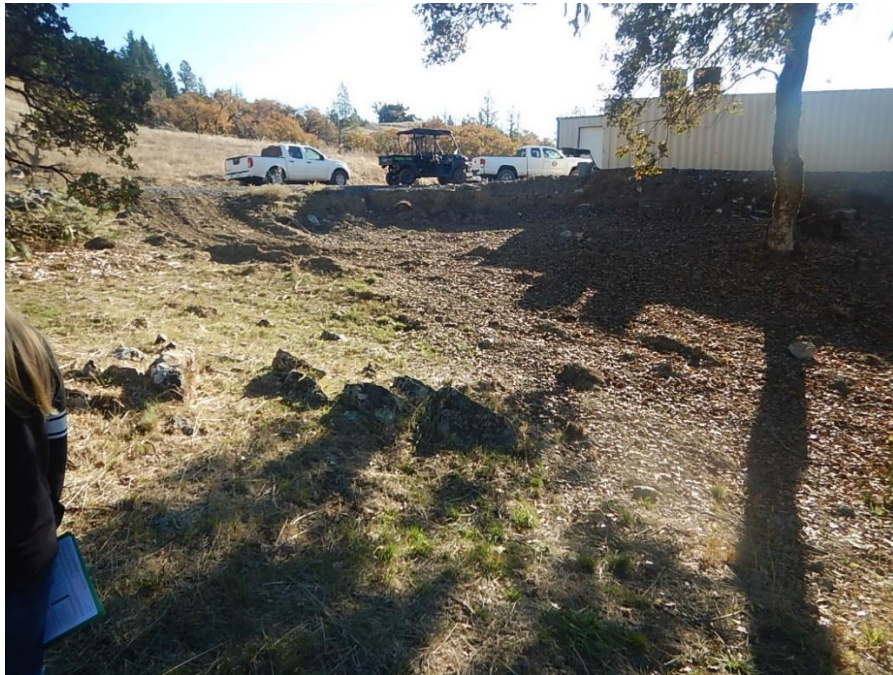
Staff followed Mendocino County personnel to the pond location labeled as WQ 1 on the map. Here we met with site representatives Mr. Jay Brown and Mr. Ehud Lissauer. Staff asked about the fuel spill alleged in a complaint and neither Mr. Brown nor Mr. Lissauer acknowledged there had been a spill. I observed that the pad occupied by a shipping container had been excavated, creating a near vertical boundary (Photo 1 and Photo 2), when asked about the excavation Mr. Brown, replied that the excavation occurred while cleaning up a fallen tree. I asked Mr. Lissauer if I could take some pictures and he said yes.

Photo 1—Looking east at area of reported diesel spill WQ 1. The pond is to the right of the image.

1. Retain a licensed professional to investigate the extent of contaminated soil, surface water and groundwater associated with the diesel spill and develop a workplan and schedule for cleaning up the spill.

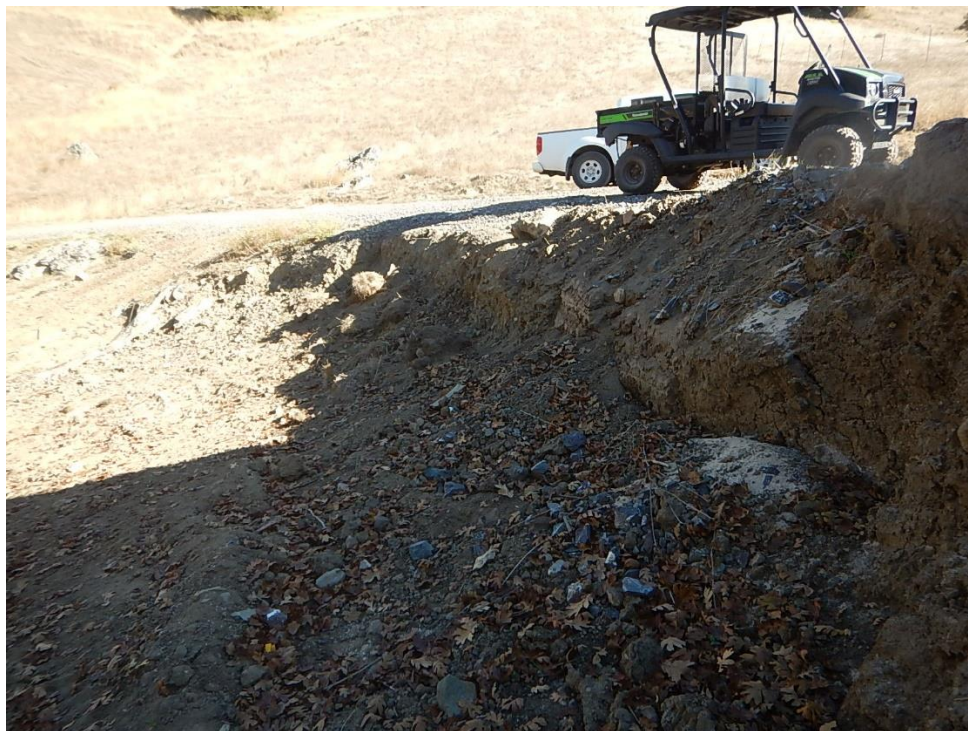
Photo 2—Looking at area of excavated bench. Some of the rock that was used to armor the bench surface can be seen in the excavation area.

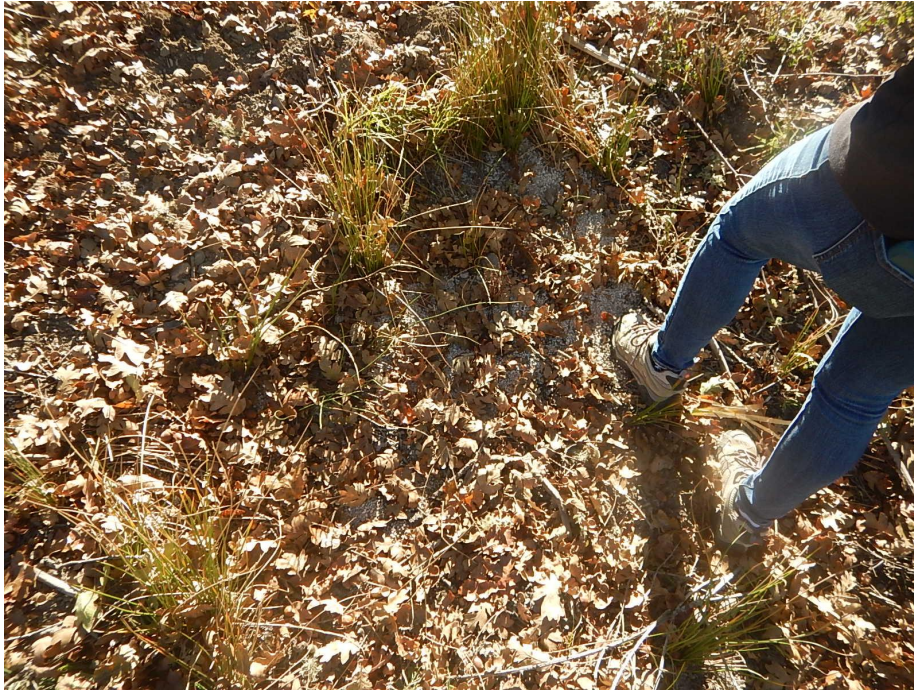
I observed a granular material that resembled kitty litter (Photo 3) and I smelled several dark clumps of earth that had a strong odor of diesel fuel. East of the contaminated soil, I observed a scour feature where surface water from the hillslope to the north (Photo 4) would flow toward the pond (Photo 5). I did not observe a culvert at this location, but the Site Management Plan map and photos 36 and 37 show a culvert at this location. The Site Management Plan does not identify this feature as a watercourse.

Photo 3—Granular material that resembles kitty litter can be seen upslope of the pond at WQ 1.

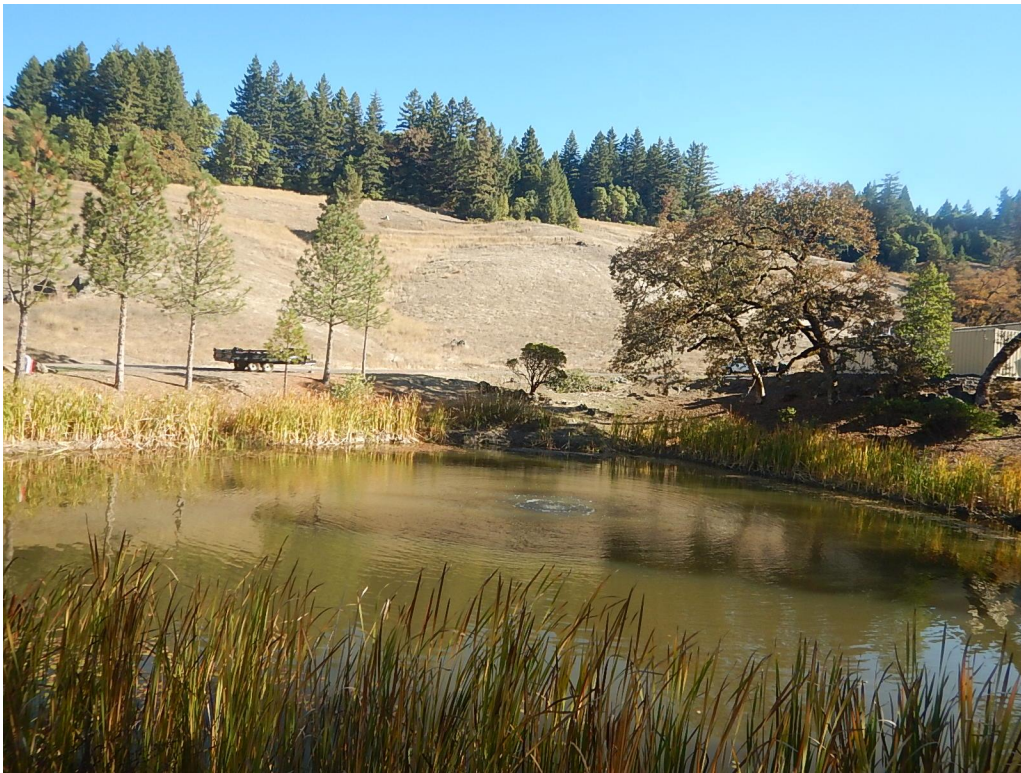
Photo 4—Looking north at the pond. The topographic form of a watercourse can be seen on the hillside in the background of the image. The watercourse passes by a tree near the center of the image also pictured in Photo 5.

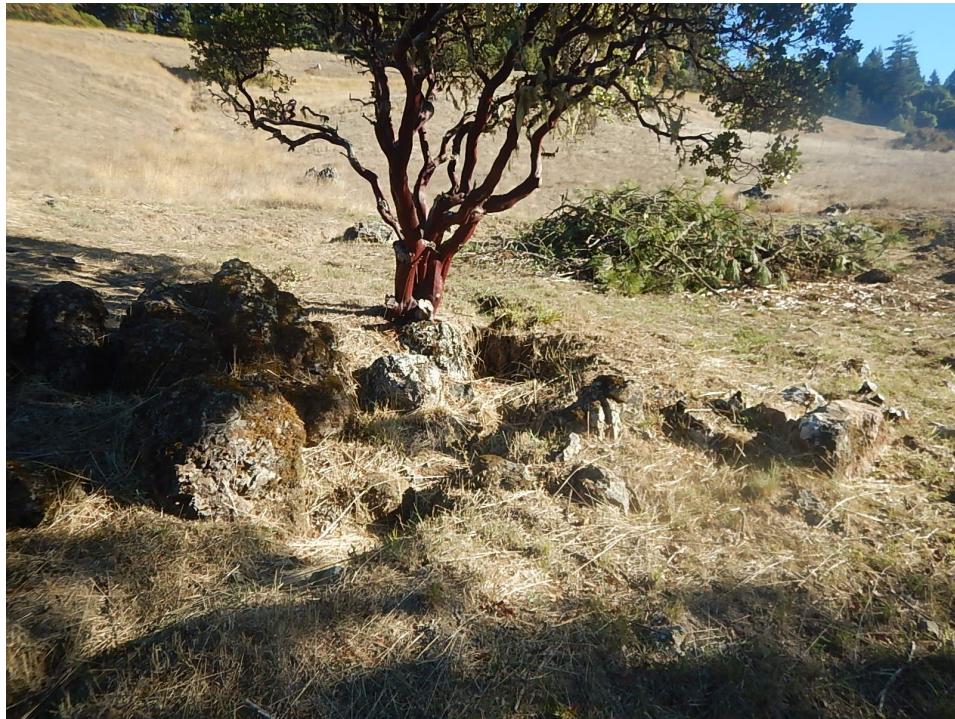
Photo 5—Shows suspected flow path of surface water from the watercourse pictured in Photo 4 before it flows south into the pond.

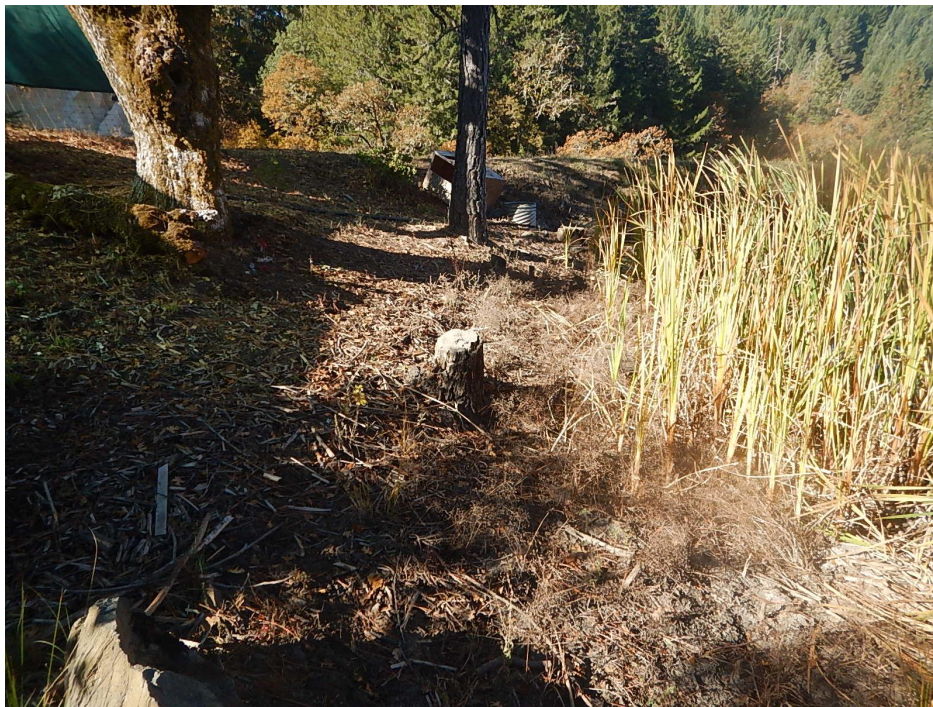
From WQ 1, I observed a standpipe on the east side of the pond (Photo 6) which delivered the pond outflow to a pipe on the southwest side of the pond (Photo 6/Photo 7). I observed a watercourse extending from the pond outlet to Sherwood Creek (Photo 8). The Site Management Plan does not identify this feature as a watercourse. The pond drainage inlet is less than 50 feet from the Cannabis cultivation pad.

Photo 6—Shows the east bank of the pond. The standpipe inlet for the pond outflow can be seen in the center back of the image.

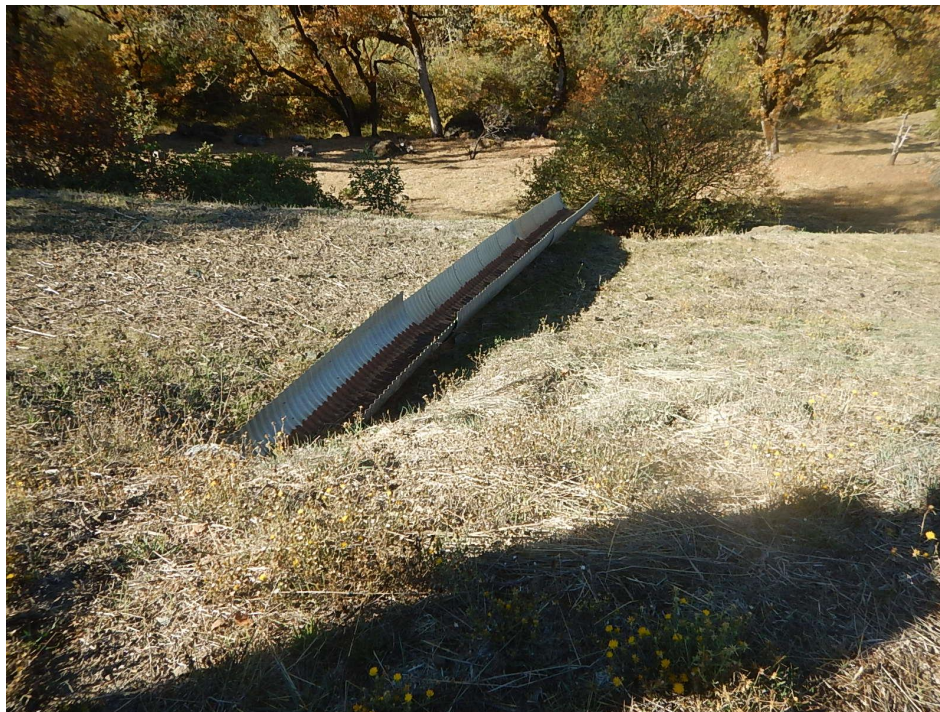
2. Stream crossing maintenance and improvement: I did not observe a culvert at WQ 1. The pond outlet is rusted and perched. The culvert at WQ 4 is narrower than the channel width and partly blocked at the inlet.

Photo 7—Shows the outlet pipe for the standpipe pictured in Photo 6.

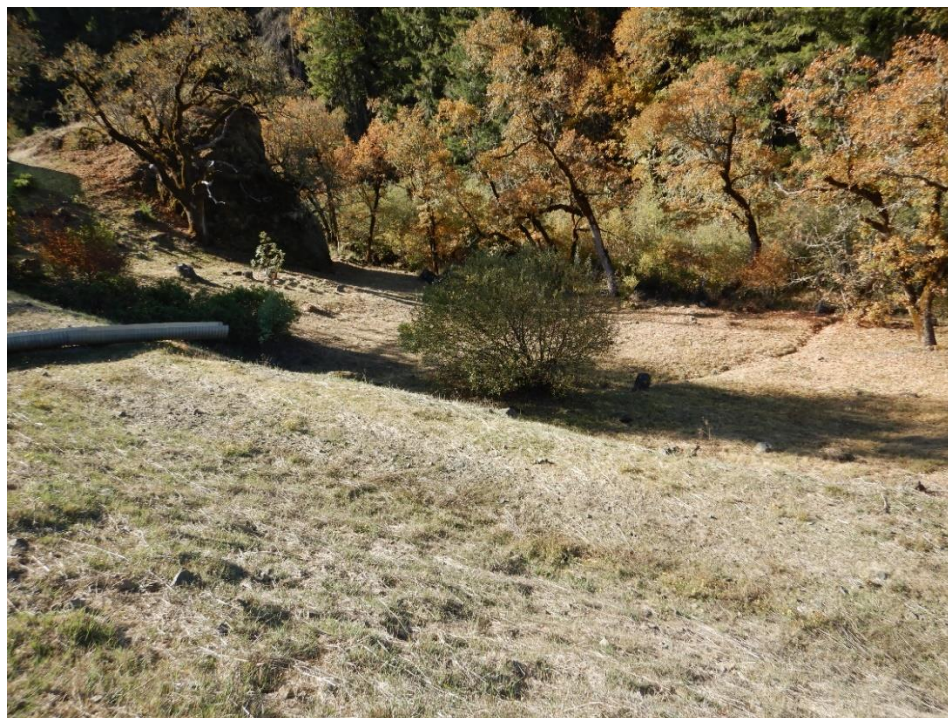
Photo 8—Shows the same outlet pipe pictured in Photo 7. Note the watercourse channel leading to Sherwood Creek in the right of the image.

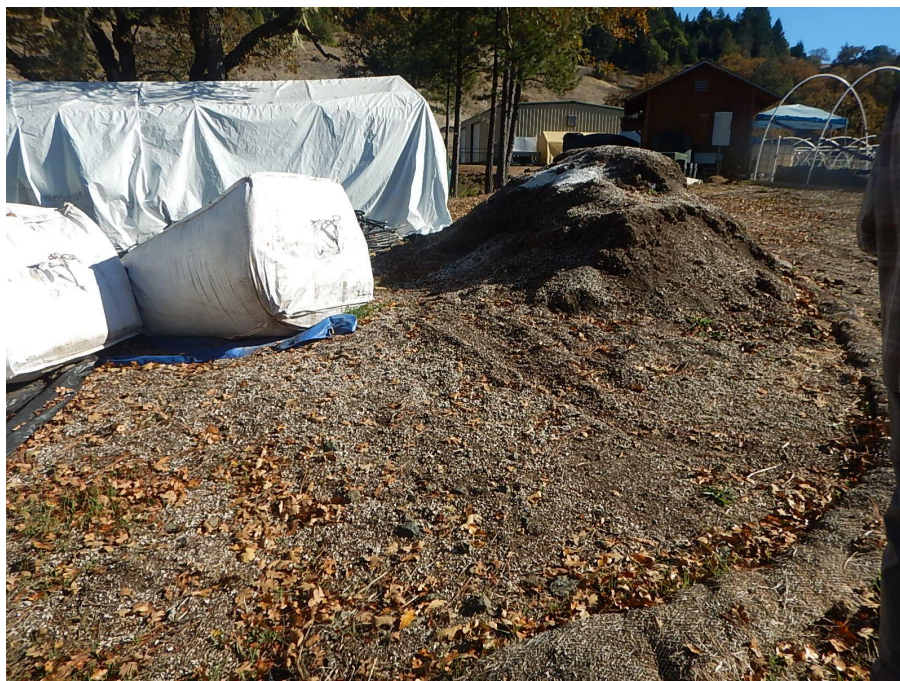
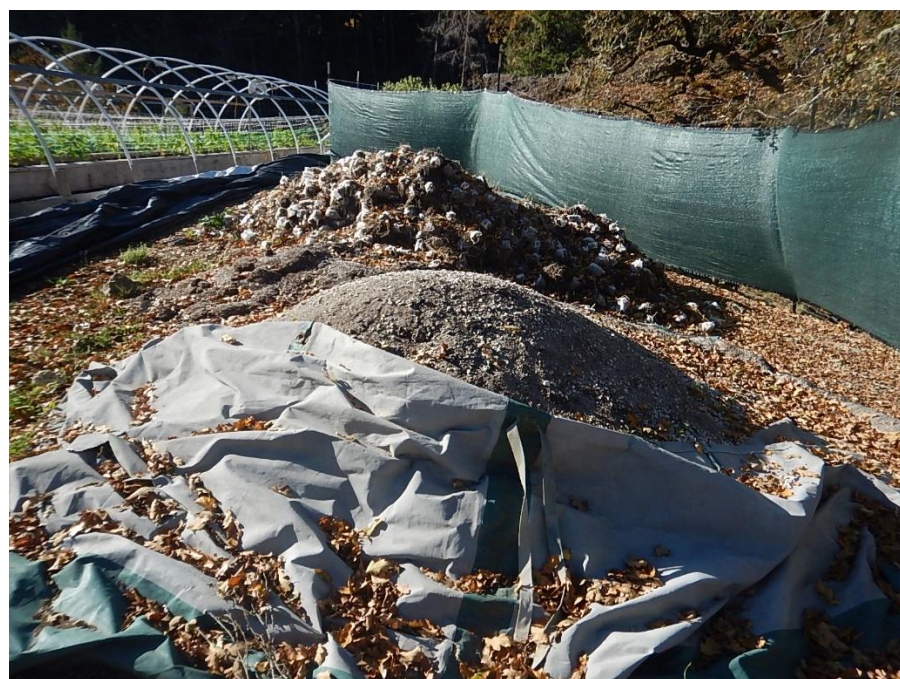
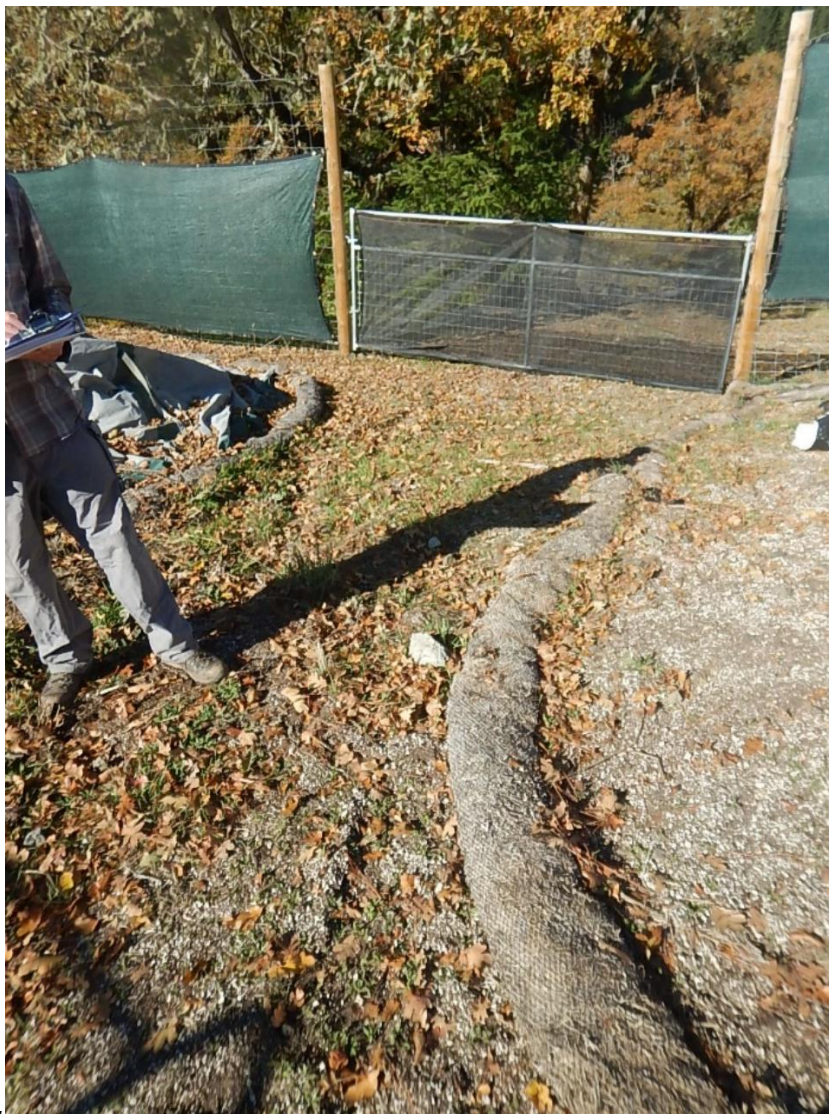
I walked from the pond to a southeastern entrance to the cultivation area at WQ 2. Here I observed potting soils uncovered and surrounded by aged/decomposed wattles which were not effective at preventing the spread of potting soils (Photo 9 and Photo 10). I observed that the potting soils were sitting on an incline dipping towards Sherwood Creek (Photo 11) and are susceptible to being transported by stormwater to receiving waters.

4. Spoils management: Potting soils at WQ 2 are uncovered and located on an incline dipping towards Sherwood Creek.
5. Water storage and use: Some water for irrigating cannabis comes from the pond which is onstream. I did not review the rain catchment system north east of the cultivation area.

Photo 9—Looking north at potting soils uncovered on bare ground in the vicinity of WQ 2.

Photo 10—Looking south at potting soils uncovered on bare ground in the vicinity of WQ 2.

Photo 11—Looking north west at potting soils uncovered on bare ground in the vicinity of WQ 2. Sherwood Creek is in the background of the image.

2. Retain a licensed professional to inventory, assess, and develop a workplan and schedule to implement measures to ensure that all developed features, roads, watercourse crossings, and cultivation areas throughout the Property are corrected, restored, and/or maintained in conditions that prevent or minimize erosion, sediment transport/delivery, and adverse impacts to water quality and beneficial uses. Include measures to ensure all land disturbance, cannabis cultivation activities, and facilities are setback the minimum required distance stated in the State Water Resources Control Board Cannabis Policy (Cannabis Policy). Dispose of all development and restoration-related earthen spoils in a manner to prevent/minimize transport and delivery to receiving waters.

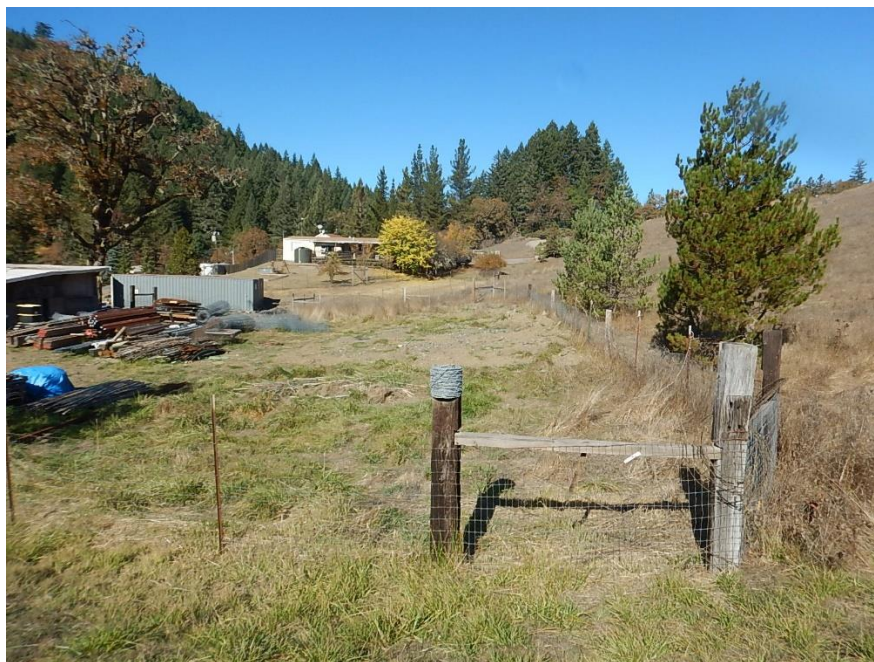
I walked back to WQ 3 and asked Mr. Lissauer if I could inspect the leach field where contaminated soil had allegedly been placed. Mr. Lissauer agreed, and I walked around the leach field located in the vicinity of WQ 3 (Photo 12). I observed earth deposited on top of vegetation and the same imported rock material that I had observed armoring the pad at WQ 1. I also smelled the odor of diesel fuel in the soil at this location.

8. Pesticides: Staff did not review pesticide use or storage on the property.
9. Petroleum products and other chemicals: Diesel fuel had been spilled above the pond and was inappropriately disposed of at the leach field. Staff did not review chemical and fuel storage areas.

Photo 12—Looking northwest at leach field area where contaminated soils was disposed of.

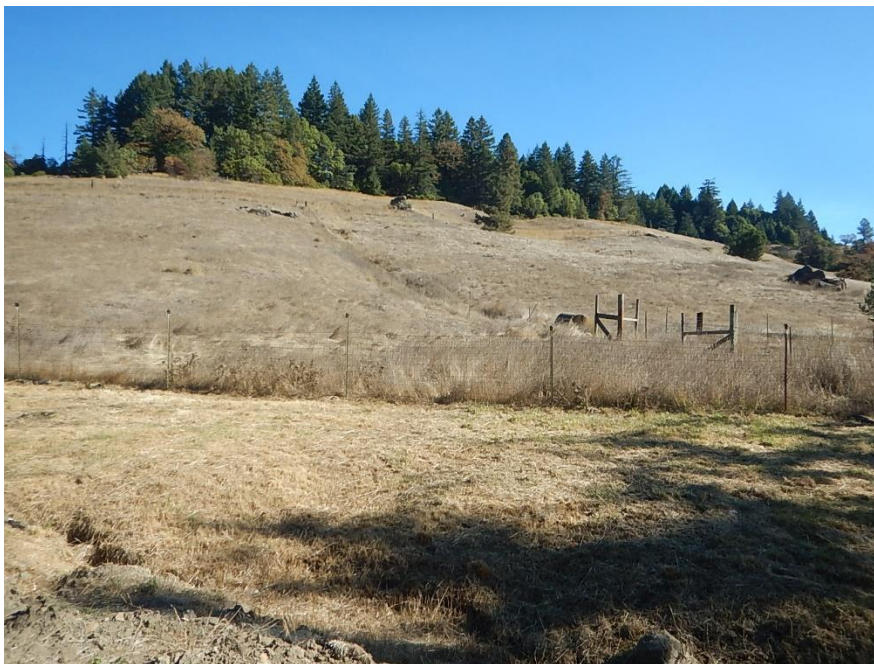
I observed the topographic form of a watercourse on the hillslope northeast of WQ 3 (Photo 13), which passes the leach field before being culverted at a road crossing at WQ 4 (Photo 14). Downstream from the road the watercourse flows towards Sherwood Creek (Photo 15). Between WQ 3 and WQ 4, I observed that the land had been disturbed by the placement of shipping containers that were encroaching on the watercourse (Photo 16 and Photo 17). I asked Mr. Brown if the storage containers were going to be used for the cannabis operation and he said yes.

Photo 13—Looking northeast from a point west of WQ 3. The topographic form of a watercourse can be seen in the center of the image.

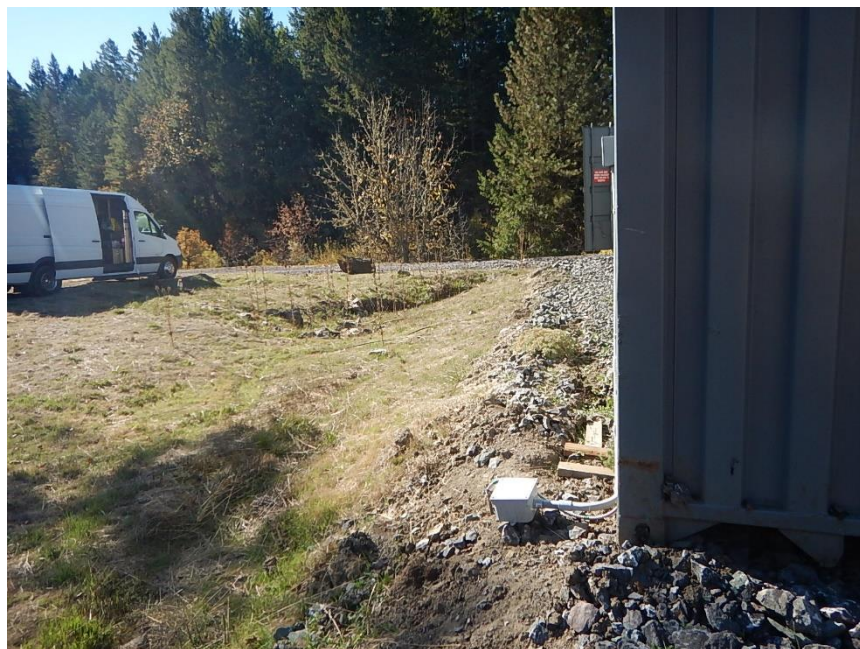
Photo 14—Looking southwest of at road crossing at WQ 3.

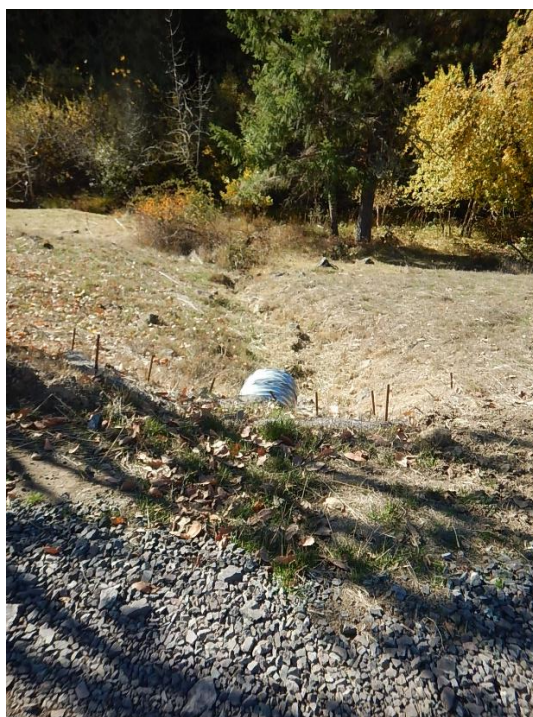
Photo 15—Looking southwest of at WQ 3 culvert outlet.

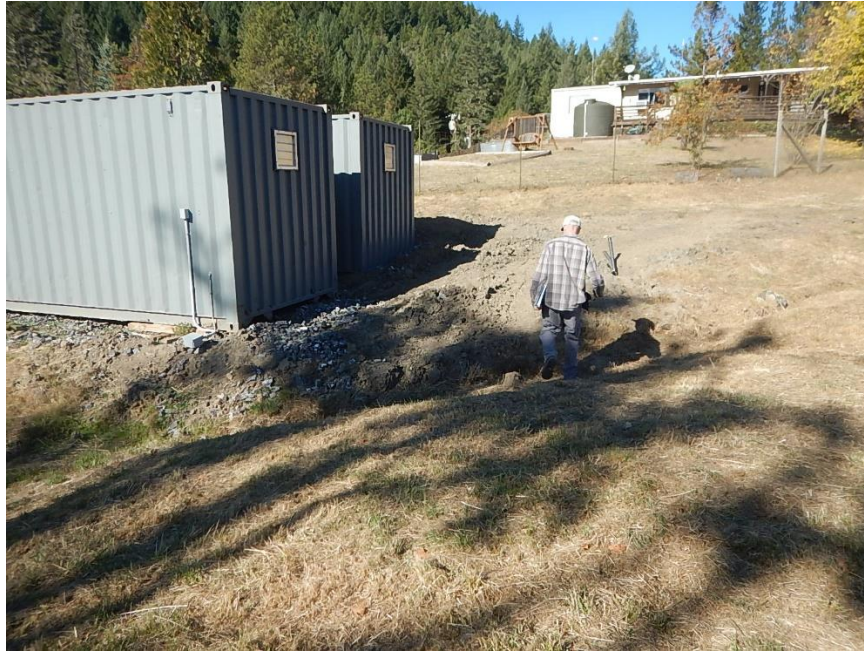
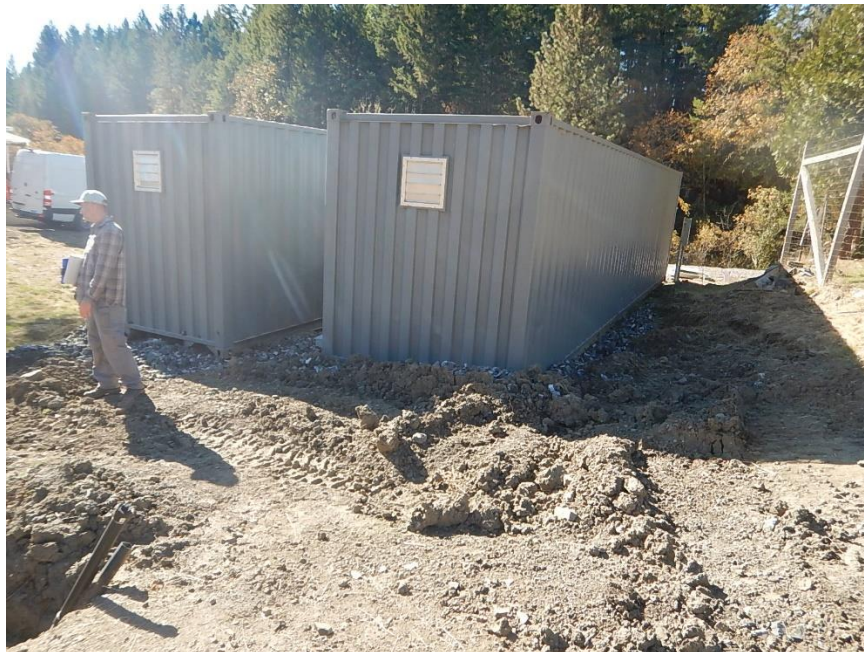
3. Riparian and wetland protection and management: The western edge of the cultivation pad dips directly into the pond to with less than 50 feet of leaf-covered earth between the pad and the pond edge when filled. This is not an adequate buffer between the cultivation area and the pond which discharges into Sherwood Creek. The pad constructed between WQ 3 and WQ 4 encroaches on a tributary to Sherwood Creek.

10. Cultivation-related wastes: As noted above, potting soils at WQ 2 are uncovered and located on an incline dipping towards Sherwood Creek.
11. Refuse and human waste: Staff observed black pipes extending from a trench within the area of disturbance for the pad constructed between WQ 3 and WQ 4. The pipes appear to connect to the septic system. Other than observing the sanitary pipe in open ditch, I did not review human waste disposal facilities on the property. I did not observe water quality concerns associated with refuse on the property.

Photo 16—Looking west at shipping containers encroaching on watercourse between WQ 3 and WQ 4. Note the septic pipe to the right of the person standing in the middle of the watercourse.

Photo 17—Looking southwest at shipping containers encroaching on watercourse between WQ 3 and WQ 4. Note black plastic pipes protruding from the ground in the lower left of the image.

6. Confirm work associated with exposing the septic lines near WQ 3 is consistent with applicable County requirements.
